# The Status of Water Quality in the Rivers and Tributaries of the Shenandoah River Watershed

Final Report (Third Edition)

August, 2007

A paper prepared by Charles Vandervoort of the Friends of the Shenandoah River with the cooperation of the Volunteer Monitors of the Shenandoah River Watershed.

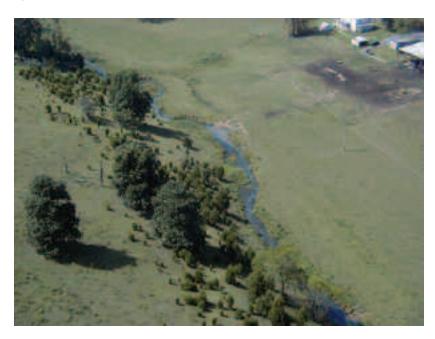
The aerial photo below shows the lack of a stream buffer on the right side of the stream, and the inadequate stream buffer of the left side of the stream. Also noteworthy is the runoff from the large muddy area near the cattle barn. The technical annex shows more of these photos taken from both the air and the ground of some of the causes of erosion.

Photo 5-1
Aerial photo
showing erosion
along Pleasant
Run

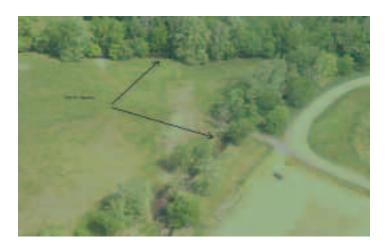
Photo 5-11 Close-Up of FW21, Gooney Run, west of Rte. 340

Photo 5-11 shows a close-up of Gooney Run after it has come down from the highlands, and near the probable location where samples are taken. The stream is well protected with a forested buffer zone and is therefore hard to hard to see from the air.
